Tenth U.S. National Conference on Earthquake Engineering
Frontiers of Earthquake Engineering
July 21-25, 2014
Anchorage, Alaska

SEISMIC PERFORMANCE OF FULL-SCALE COLD-FORMED STEEL BUILDINGS

Seismic Performance of Full-Scale Cold-Formed Steel Buildings

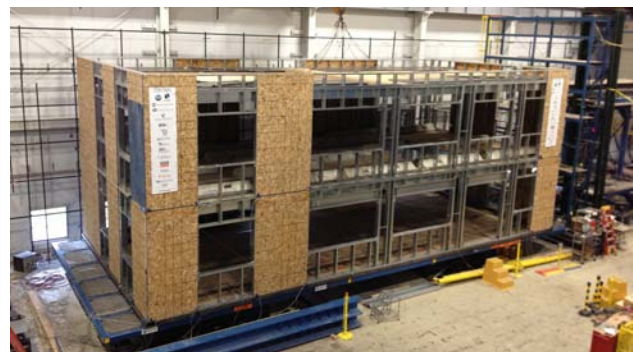
The CFS-NEES building test specimens were designed as a CFS archetype—intended to be representative of modern cold-formed steel practices for commercial construction, and was sited for the purposes of design in Orange County, California, USA [8] [9]. The buildings were designed with ledger framing, and with OSB-sheathed CFS-framed shear walls as the lateral force-resisting system. The gravity walls and floor and roof diaphragms were also framed entirely of structural CFS. Figure 1 depicts the shear walls (sheathed) and the gravity system.

Figure 1. At left, engineering drawing of the LRFS and gravity system, at right, the Phase 1 building as built and tested.

Henceforth, the bottom-most level of the building will be referred to as the “foundation” level, the second story floor will be referred to as the “floor” and the second story ceiling/roof will be referred to as the “roof.” The front facing wall of the building (Figure 1) is the South side, with the other building faces following the cardinal directions.

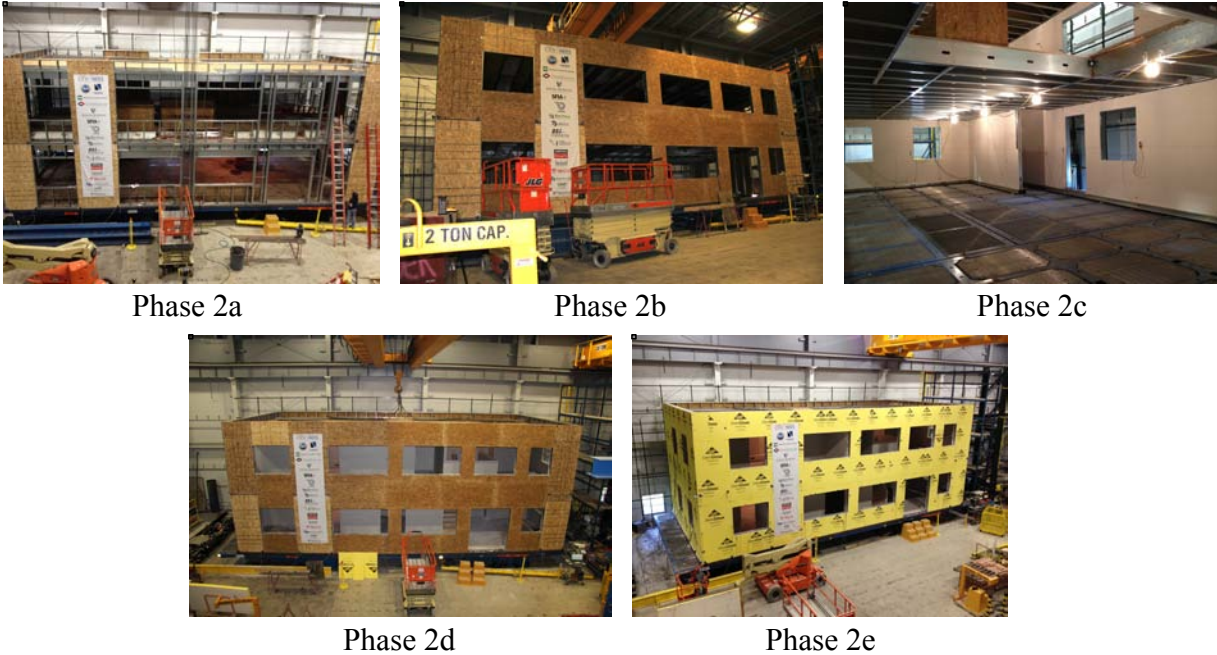
Figure 3. As-built sub-phases of Phase 2 testing. Note, in Phases 2c and 2d, additions are only made to the interior of the building.

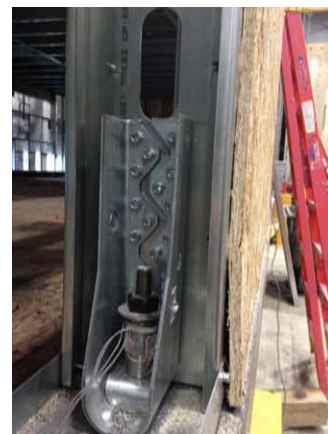
Excitation:p1s07, t=8.8242 s, scale=50

Utilizing the load cells installed on the shear wall hold downs, it is possible to examine load transfer between and amongst shear walls. Despite the fact that the shear walls were designed as Type 1 shear walls, it is clear from the anchor force distribution in Figure 5 that in many important ways they behave as Type 2 shear walls [12].

Figure 5. Left: Phase 1 building at peak drift, with plots of hold down forces. Clustered hold down forces (all red, for example), indicate Type 2 behavior. Right: photograph of load cell installed in shear wall hold down.

This characteristic implies that the building system behavior is not simply a superposition of shear wall behavior, and that tests on shear walls alone are not sufficient for building predictions.
